EXECUTIVE SUMMARY

OBSERVATIONS & RECOMMENDATIONS

Pine Island Pond, Manchester

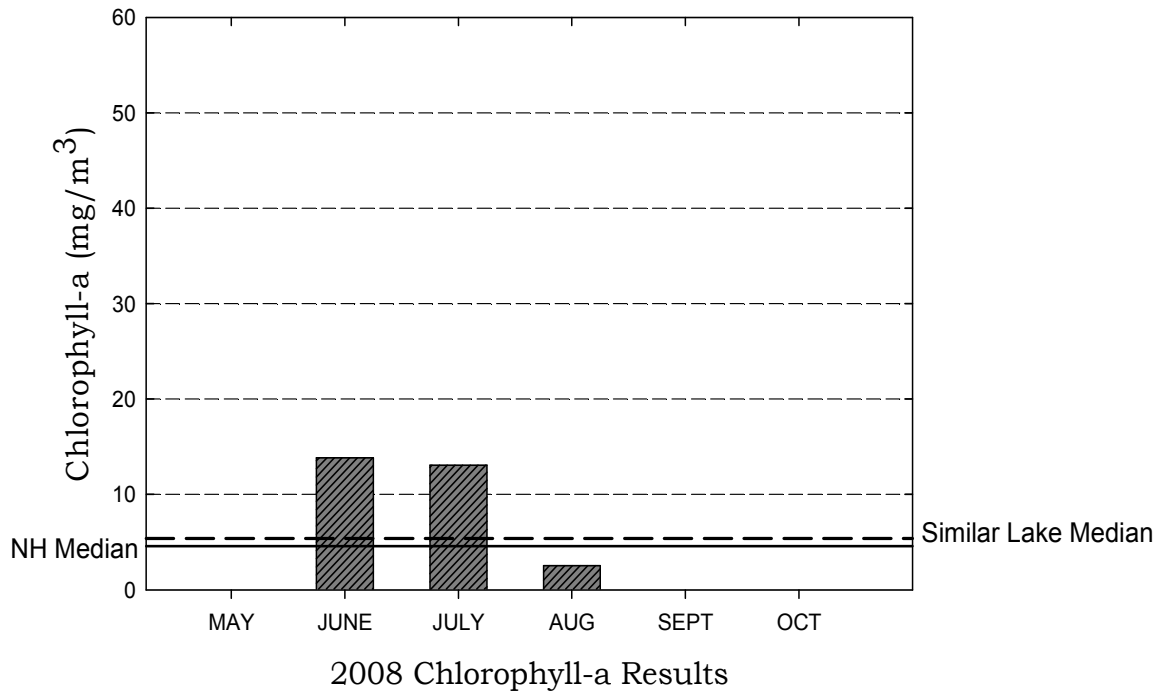
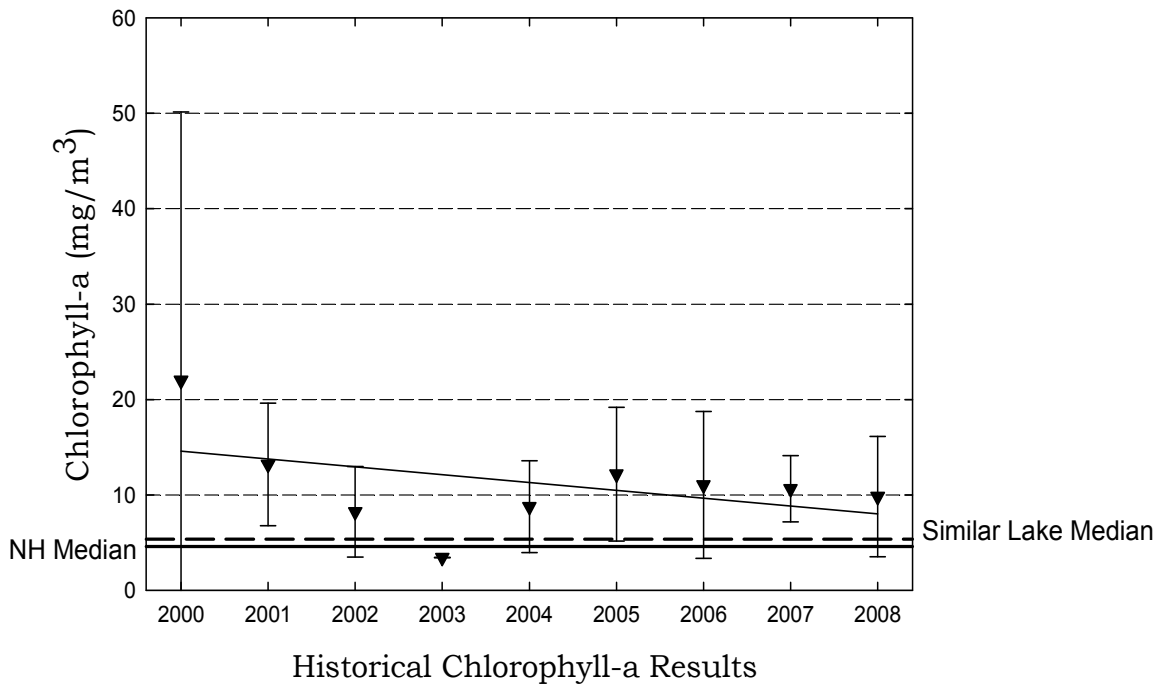
Figure 1. Monthly and Historical Chlorophyll-a Results

Figure 1 depicts the historical and current year chlorophyll-a concentration in the water column.

The current year data (the top graph) show that the chlorophyll-a concentration **decreased slightly** from **June** to **July**, and then **decreased greatly** from **July** to **August**.

Please note that the June and July chlorophyll-a concentrations were **elevated**. Typically, chlorophyll-a concentrations above **15 mg/m³** are indicative of an algal bloom.

The historical data (the bottom graph) show that the **2008** chlorophyll-a mean is **greater than** the state and similar lake medians. For more information on the similar lake median, refer to Appendix D.

Overall, visual inspection of the historical data trend line (the bottom graph) shows a **variable** in-lake chlorophyll-a trend since monitoring began. Specifically the mean chlorophyll concentration has **fluctuated between approximately 2.90 and 21.98 mg/m³** since **2000**.

Therefore, it is extremely important for volunteer monitors to continually educate all watershed residents about management practices that can be implemented to minimize phosphorus loading to surface waters.

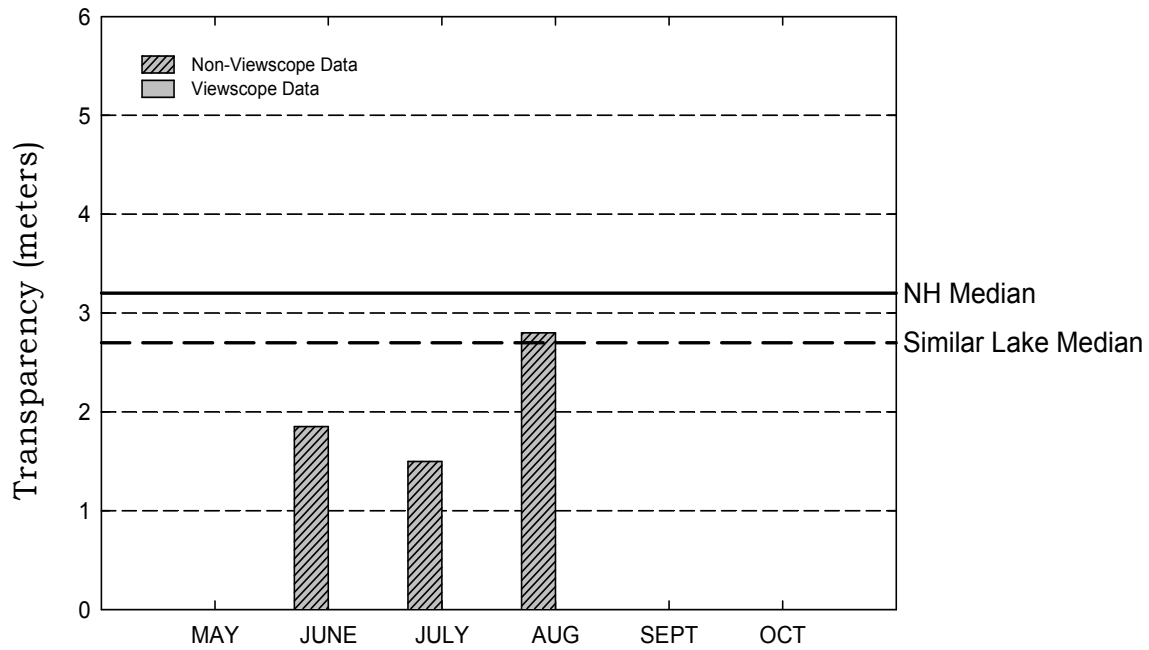
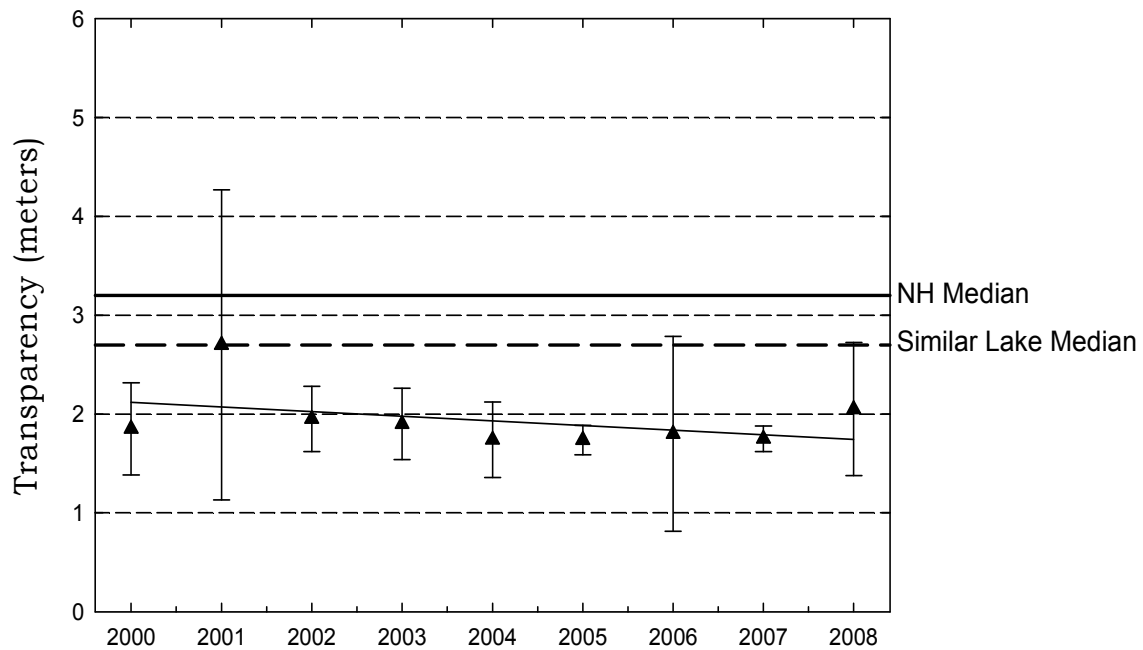
Figure 2. Monthly and Historical Transparency Results

Figure 2 depicts the historical and current year transparency *with and without* the use of a viewscope.

The current year *non-viewscope* in-lake transparency *decreased* from **June** to **July**, and then *increased* from **July** to **August**.

It is important to note that as the chlorophyll concentration *decreased* from **July** to **August**, the transparency *increased*. We typically expect this *inverse* relationship in lakes. As the amount of algal cells in the water *decreases*, the depth to which one can see into the water column typically *increases*, and vice-versa.

The historical data (the bottom graph) show that the **2008** mean non-viewscope transparency is ***less than*** the state and similar lake medians. Please refer to Appendix D for more information about the similar lake median.

Visual inspection of the historical data trend line (the bottom graph) shows a ***stable*** trend. Specifically, the transparency has ***remained relatively stable ranging between 1.80 and 2.70 meters*** since monitoring began in **2000**.

2008 Transparency Viewscope and Non-Viewscope Results

Historical Transparency Non-Viewscope Results

Typically, high intensity rainfall causes sediment-laden stormwater runoff to flow into surface waters, thus increasing turbidity and decreasing clarity. Efforts should continually be made to stabilize stream banks, pond shorelines, disturbed soils within the watershed, and especially dirt roads located immediately adjacent to the edge of tributaries and the pond. Guides to best management practices that can be implemented to reduce, and possibly even eliminate, nonpoint source pollutants, are available from DES upon request.

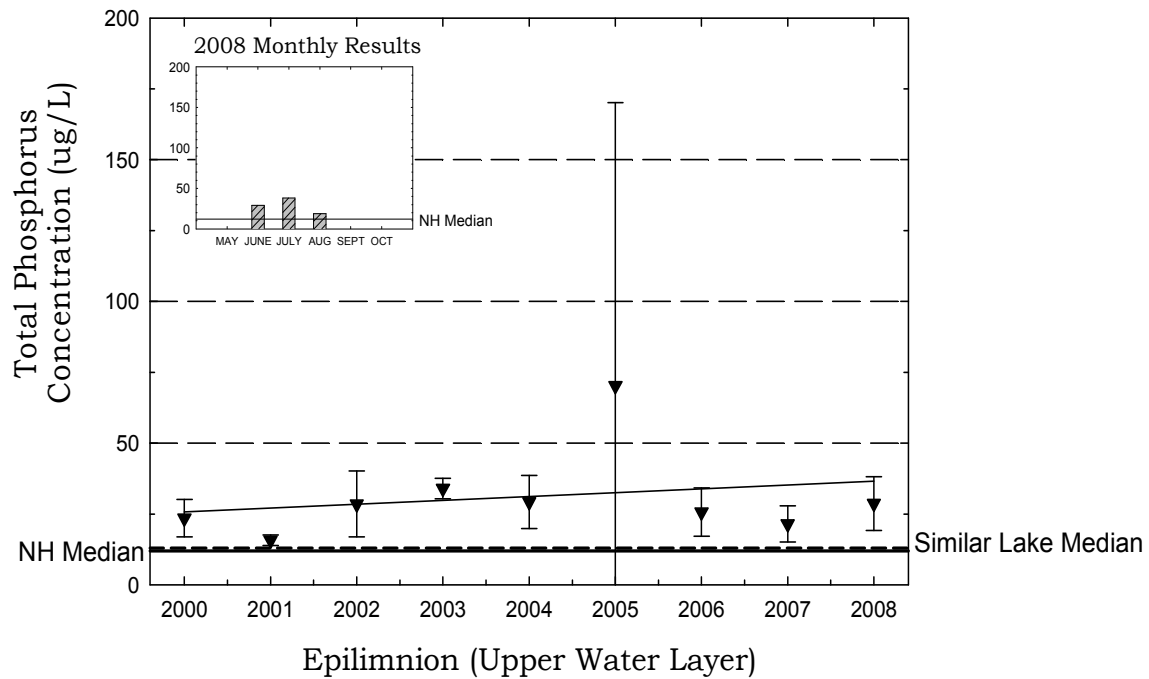
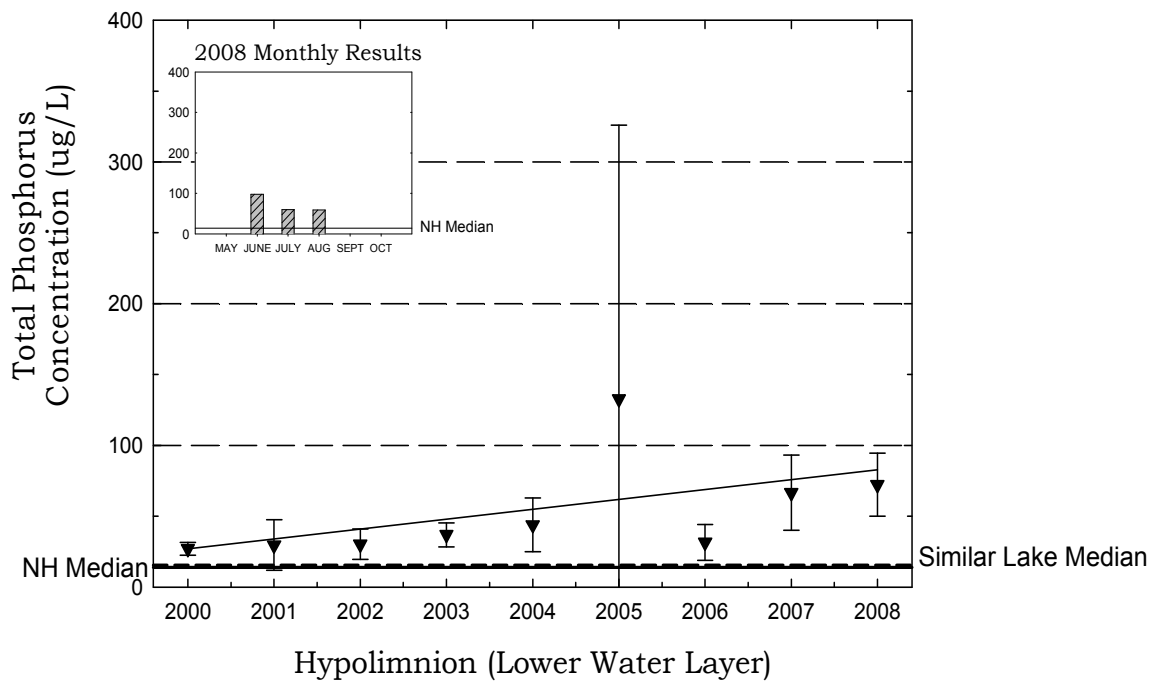
Figure 3. Monthly and Historical Total Phosphorus Data

The graphs in Figure 3 depict the historical amount of epilimnetic (upper layer) and hypolimnetic (lower layer) total phosphorus concentrations; the inset graphs depict current year total phosphorus data.

The current year data for the epilimnion (the top inset graph) show that the phosphorus concentration **increased** from **June** to **July**, and then **decreased** from **July** to **August**.

The **elevated** epilimnetic phosphorus concentration measured on the **July** sampling event may have been due to phosphorus-enriched stormwater runoff that flowed into the surface layer of the pond. Field data indicate large amounts of rainfall were measured in the week prior to sampling.

The historical data show that the **2008** mean epilimnetic phosphorus concentration is **much greater than** the state and similar lake medians. Refer to Appendix D for more information about the similar lake median.

The current year data for the hypolimnion (the bottom inset graph) show that the phosphorus concentration **decreased** from **June** to **July**, and then **remained stable** from **July** to **August**.

The hypolimnetic (lower layer) turbidity samples were **elevated** on the **July** and **August** sampling events (**11.5, and 49 NTUs**). This suggests that the pond bottom may have been disturbed by the anchor or by the Kemmerer Bottle while sampling and/or that the pond bottom is **covered by an easily disturbed thick organic layer of sediment**. When the pond bottom is disturbed, phosphorus rich sediment is released into the water column. When collecting the hypolimnion sample, make sure that there is no sediment in the Kemmerer Bottle before filling the sample bottles.

The historical data show that the **2008** mean hypolimnetic phosphorus concentration is **much greater than** the state and similar lake medians. Please refer to Appendix D for more information about the similar lake median.

Overall, visual inspection of the historical data trend line for the epilimnion shows a **variable** phosphorus trend. Specifically, the mean annual epilimnetic

phosphorus concentration has ***fluctuated between approximately 15.8 and 52.7 ug/L*** since monitoring began in **2000**.

Overall, visual inspection of the historical data trend line for the hypolimnion shows an ***increasing*** phosphorus trend since monitoring began. Specifically the mean annual concentration has ***worsened*** since monitoring began in **2000**.

One of the most important approaches to reducing phosphorus loading to a waterbody is to continually educate watershed residents about the watershed sources of phosphorus and how excessive phosphorus loading can negatively affect the ecology and the recreational, economical, and ecological value of lakes and ponds.
